Inspection Report

Property Address:
79 North Lake Drive
Santee Nacoochee, GA 30571

Superior Home Inspections

Date: 8/27/2009	Time: 10:00 AM	Report ID: jsslone092709
Property: 79 North Lake Drive Santee Nacoochee, GA 30571	Customer: James Slone	Real Estate Professional:

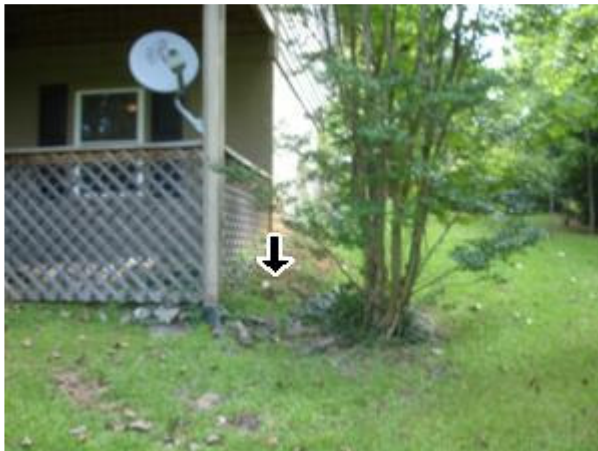
1.0 Picture 1

(1) Foundation drain line was not found at right side of home facing rear. Foundation drain lines are designed to relieve moisture buildup along the foundation wall. Further damage from moisture can occur if not corrected. Recommend further evaluation and repairs by a qualified contractor.

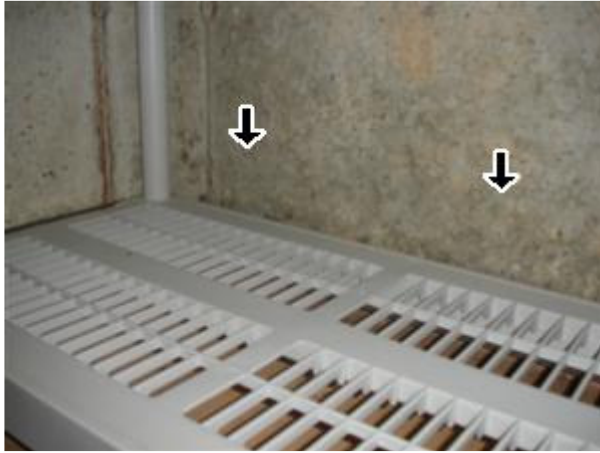
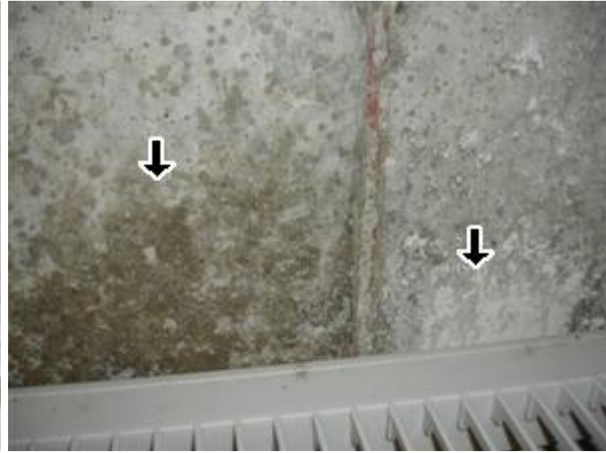
1.0 Picture 2

(2) White efflorescence (powder like substance) on block wall indicates moisture is in contact with masonry. Moisture meter indicated excessive levels at storage/mechanical room. Recommend checking gutters and downspout drain lines for proper operation, also the A/C condensation drain line is located at this area. Further damage from moisture can occur if not repaired properly. Recommend repairs by a qualified water proofing contractor or foundation specialist.

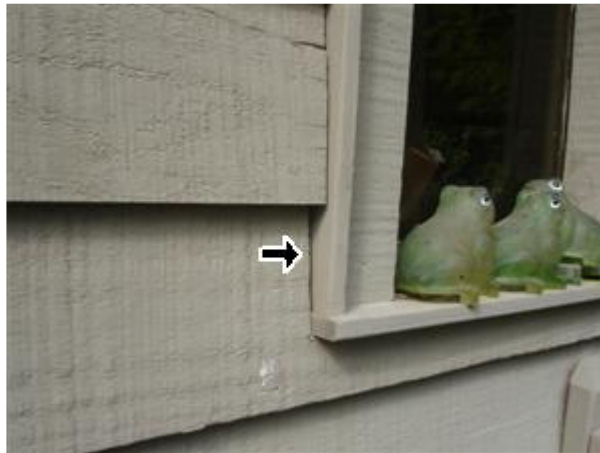
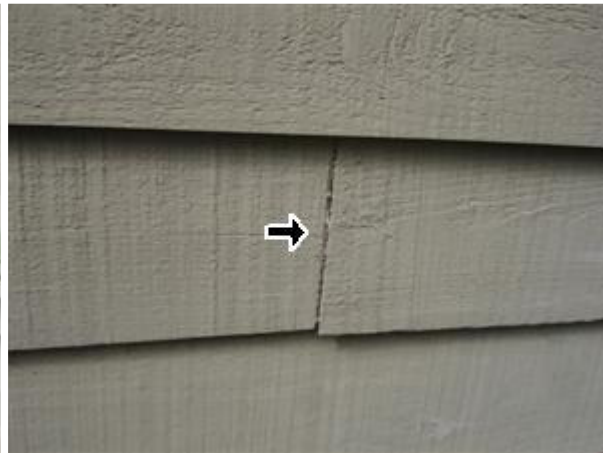
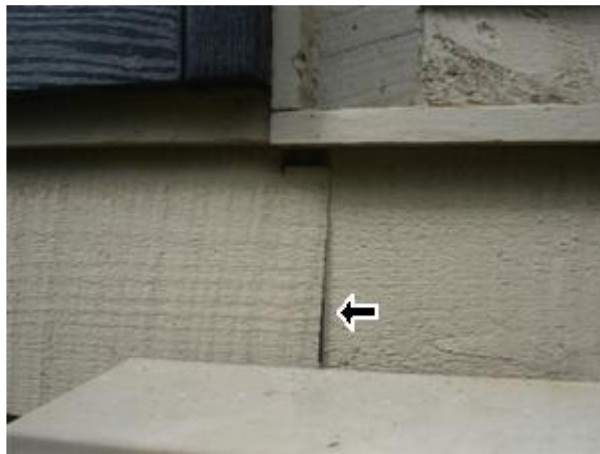
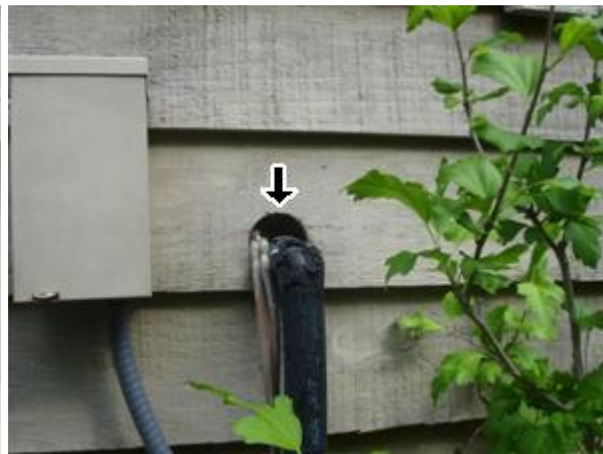
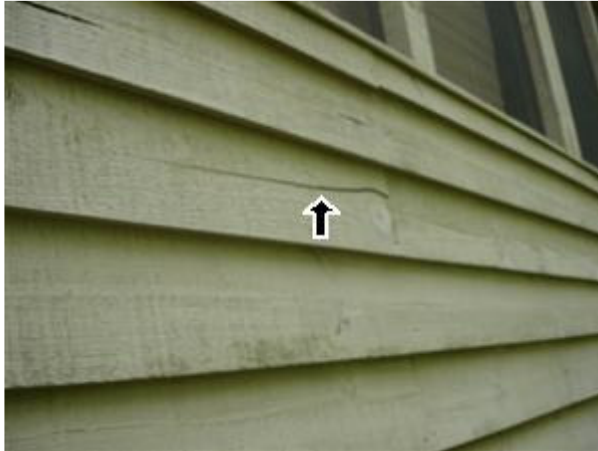
2.0 Picture 1

Wood siding at "All of exterior in areas" needs sealant at joints and hairline cracks. Further deterioration can occur from moisture entering behind these areas if not corrected. Recommend repairs by a qualified contractor.

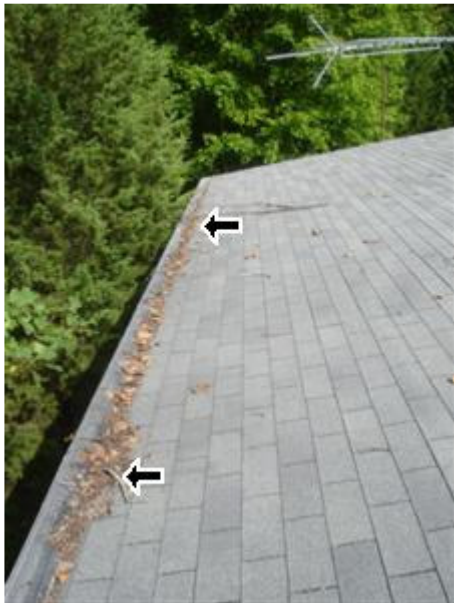
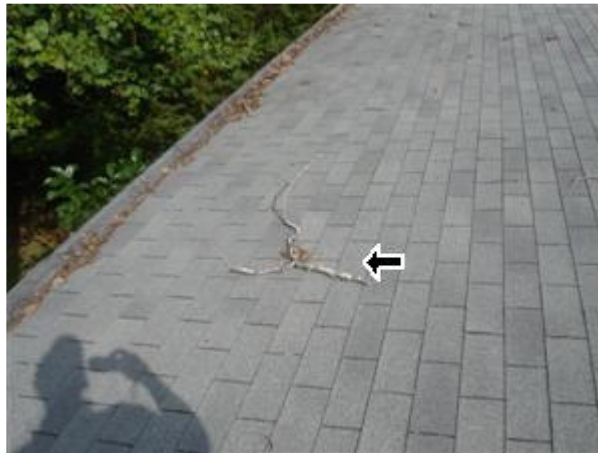
3.0 Picture 1

(1) Roof shingles have excessive debris build up at rear of home. Further damage can occur from moisture if not corrected. Recommend repair by a qualified roofing contractor.

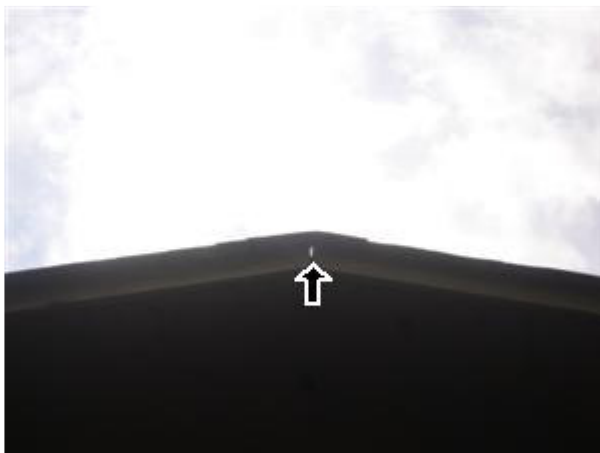
3.0 Picture 3

(2) Roof shingle is damaged/torn at right side of home facing front. Further damage can occur from moisture if not corrected. Recommend repair by a qualified roofing contractor

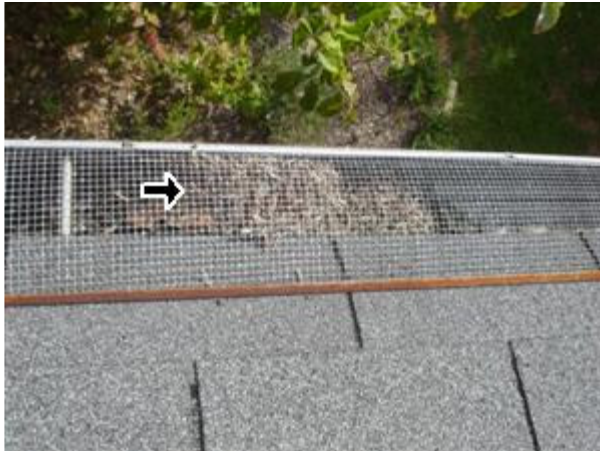
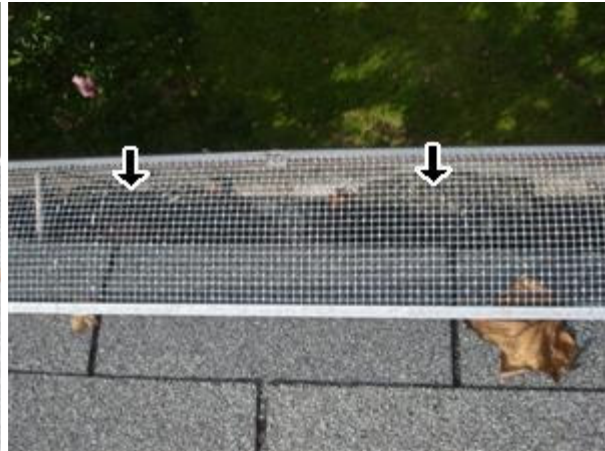
3.3 Picture 1

(1) Gutters are clogged at most areas where installed. Clogged gutters can cause deterioration of the fascia, soffit, and roof edge if not corrected. Recommend repair by a qualified contractor.

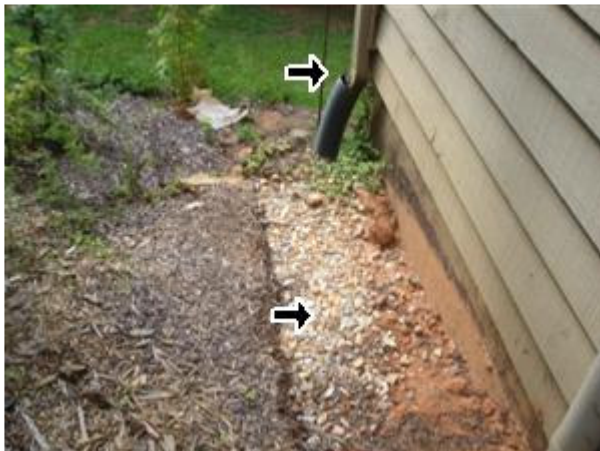
3.3 Picture 3

(2) Gutter down spout is clogged and overflowing at front of home. Erosion, and harmful water penetration is occurring and can continue occur to the home if not corrected. Recommend repairs by a qualified contractor.

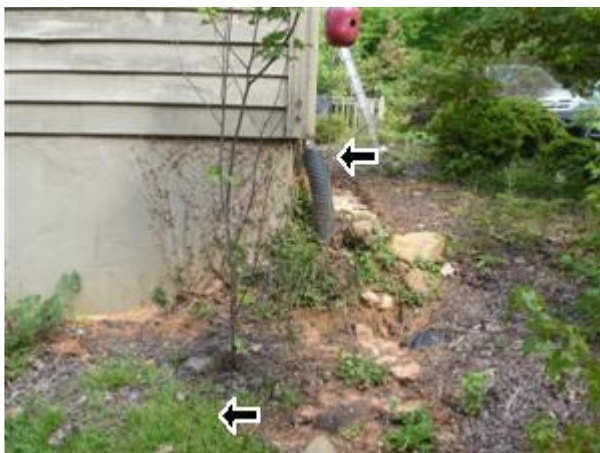
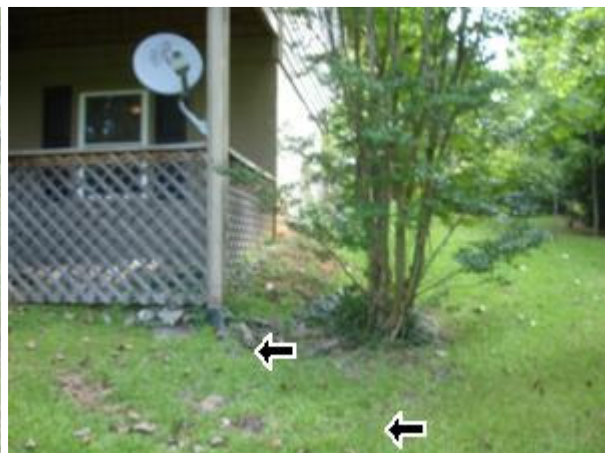
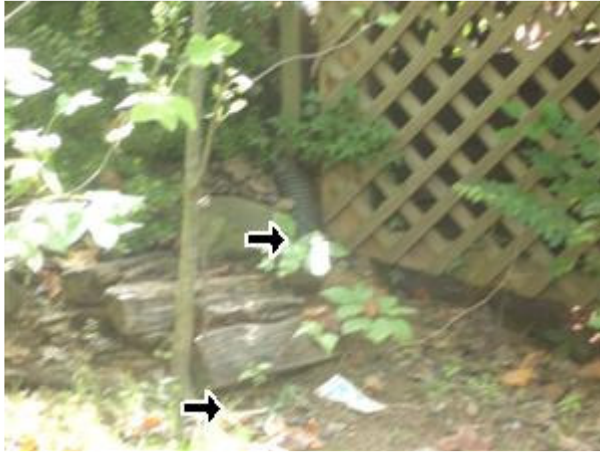
3.3 Picture 4

(3) Gutter down spout drain extensions at front/rear of home were not found at the time of inspection. Recommend further evaluation and repairs by a qualified contractor.

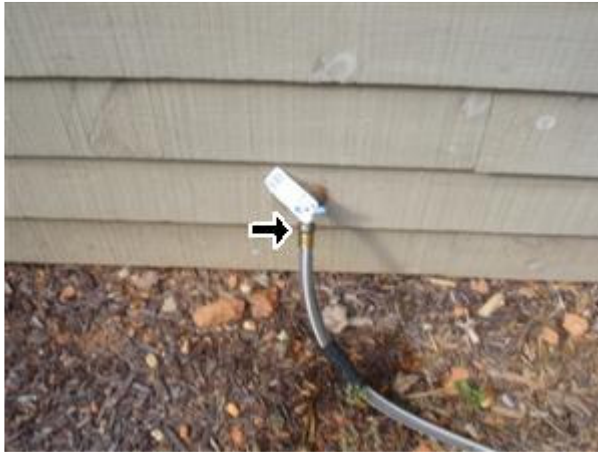
4.0 Picture 1

Water hose at front of home leaks at connection when turned on. A leaking hose can cause harmful water build up along the foundation wall leading to excessive moisture in the basement. Recommend repair by a qualified person.

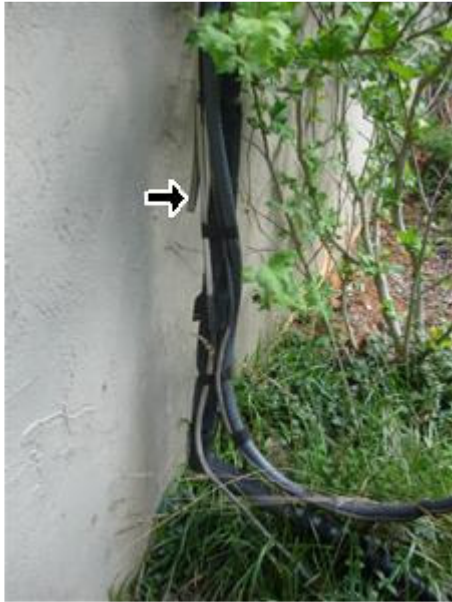
6.0 Picture 1

A/C condensation line is draining next to the foundation. This can cause excessive moisture build up along the foundation wall leading to excessive moisture build up in the basement. Recommend repairs by a licensed HVAC contractor.

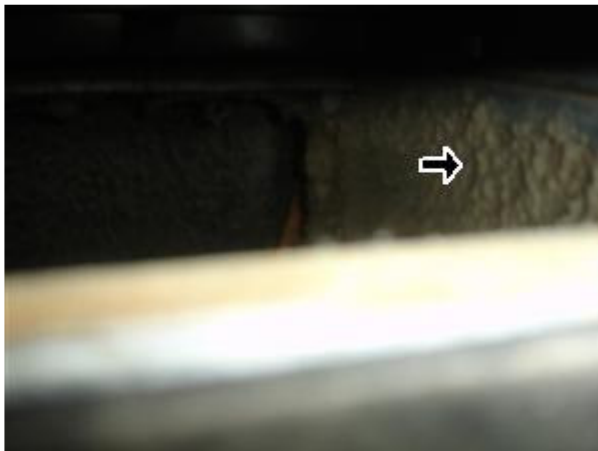
6.1 Picture 1

HVAC duct work is full of dust/debris. A thorough duct cleaning will help with the indoor air quality of your home. Recommend repair by a qualified duct cleaning company.

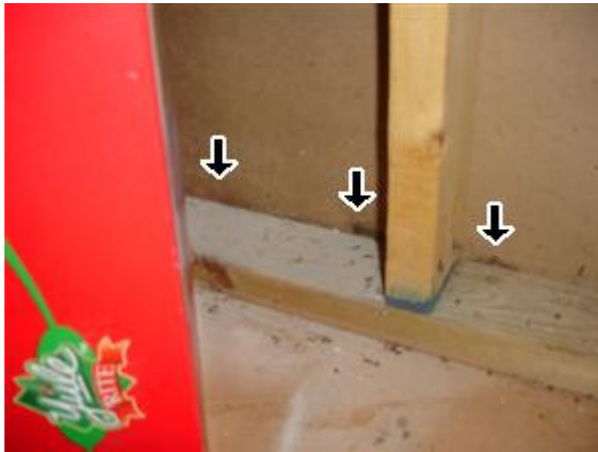
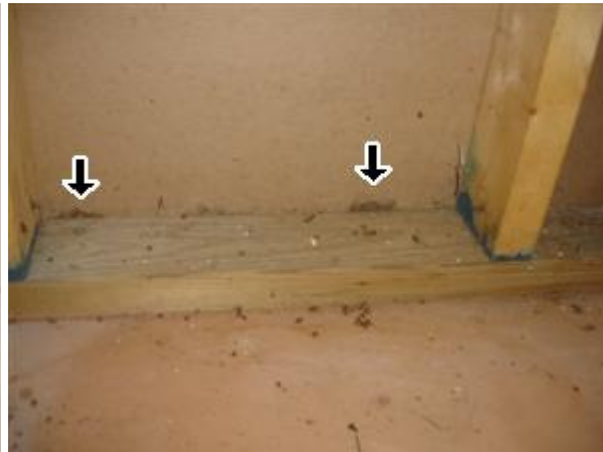
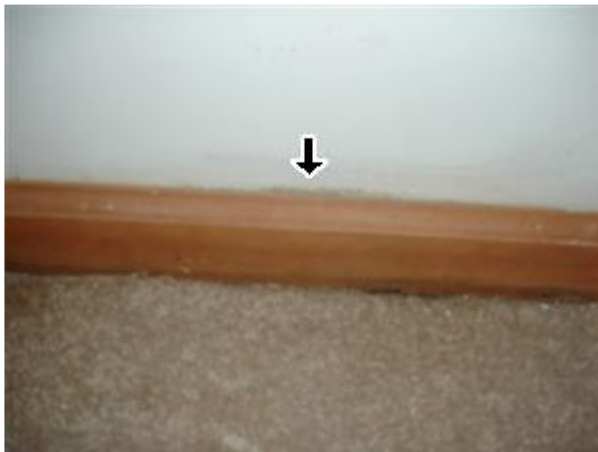
7.1 Picture 1

Signs of a mold like substance are present on walls at basement storage/mechanical room and guest bedroom. A mold swab was taken to determine if this is or is not a mold substance. Recommend contacting a mold remediation company for proper removal and repairs.

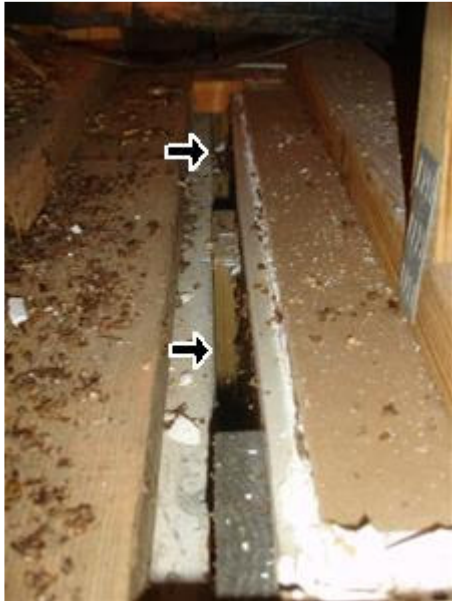
8.0 Picture 1

It appears that no air gap or vapor barrier is present with wall framing at basement guest bedroom. This issue can promote mold growth on the back side of sheetrock. Recommend further evaluation and any repairs by a certified mold remediation specialist.

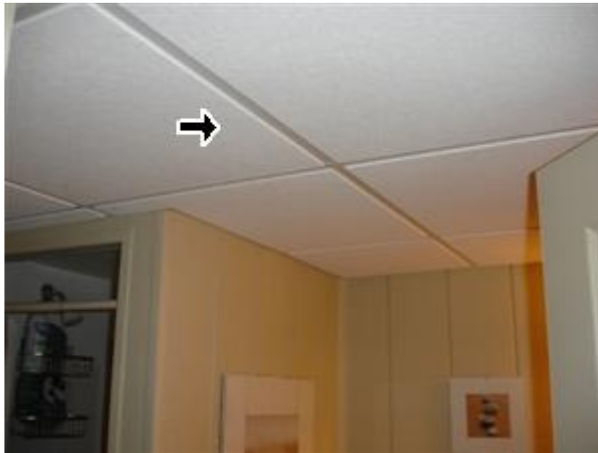
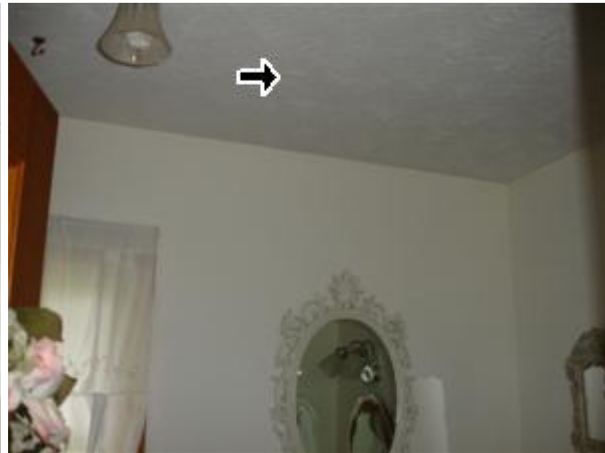
8.2 Picture 1

Bathroom exhaust vent fans were not present at all 3 bathrooms. Exhaust vent fans help remove the excessive moisture that is known to build up in bathroom areas. Excessive moisture can lead to mold growth if not corrected. Recommend repairs by a qualified contractor.
